# Updated information on the possible presence of a crack on one of the steel chain links of the Petzl ZIGZAG and ZILLON

July 23, 2014

This message follows the information issued May 19, 2014

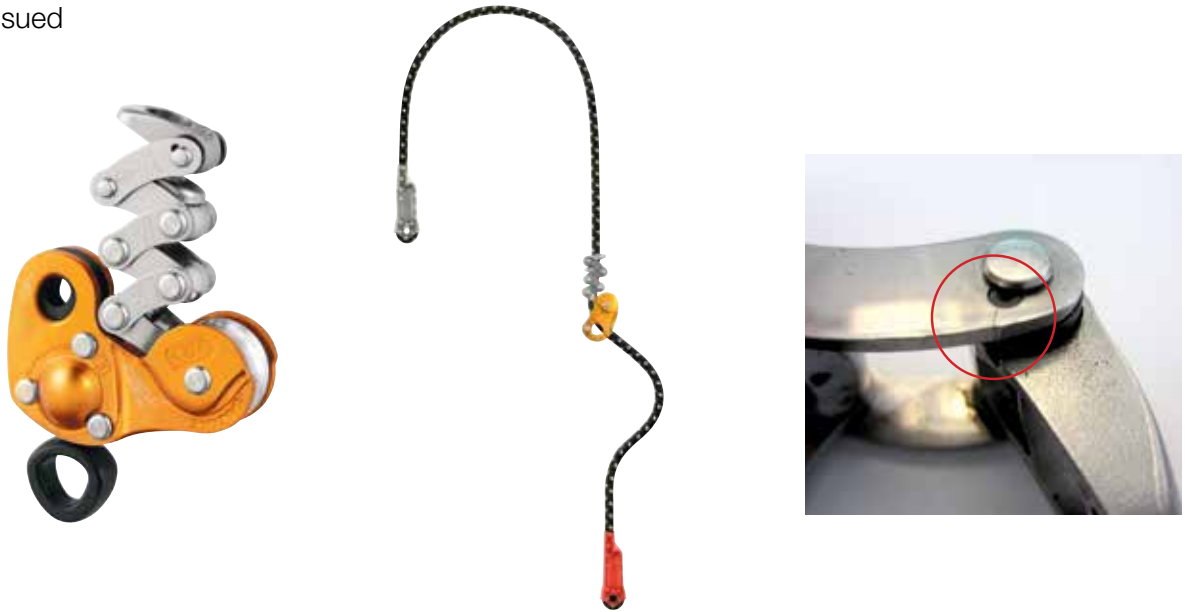
- Several ZIGZAGs have been returned to Petzl with a cracked friction chain link.
- The return rate remains below 2/1000.
- No incidents or accidents have been reported to us.
- Both ZIGZAG and ZILLON friction chain links are affected.
- When a crack appears, it is always on the same side of the friction chain links.
- All devices returned to us with a cracked link have been replaced under warranty.

Petzl has identified the root causes of the appearance of these cracks. They are the result of a combination of three parameters:

- Riveting parameters on one side that create potential residual tensile stress in the friction chain link.
- The small cross section of the link near the rivet position.
- Heat treatment that results in this part being too rigid.

- A crack can appear over time. The gradual appearance of these cracks makes them undetectable during final inspection.
- Only a very low percentage of ZIGZAG/ZILLON devices (2 out of 1000) may potentially develop such a crack.

- A cracked link presents no additional immediate risk to the user. However, as with any personal protective equipment (PPE), the presence of such a crack requires immediate retirement of the device.
- Considering the very low rates of potentially cracked links, and taking into consideration that a cracked link presents no additional immediate risk to the user, only cracked devices will be replaced.
- The replacement of a cracked device will be carried out under warranty. The warranty for this defect has been extended to 10 years.
- Regularly inspect your device in accordance with the Petzl PPE checking procedure.
- In the unlikely event you find a cracked link, retire your device immediately and contact the Petzl distributor in your country.
